Honoring The Past and Looking to the Future: Guidelines for Identification and Preservation in Saugerties, New York

SUMMARY

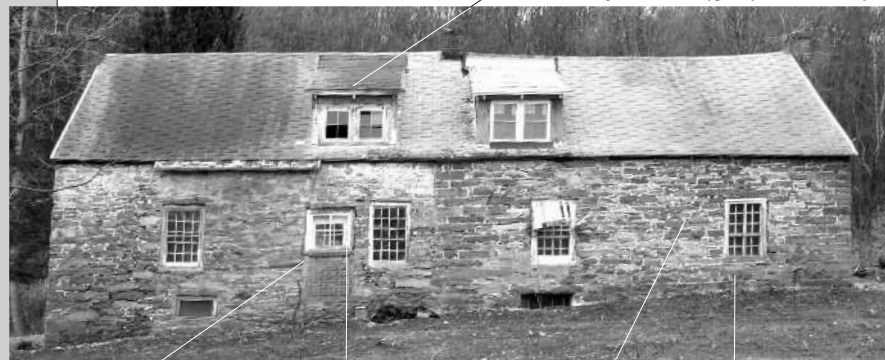
Mating seam of original house (random stone courses) Merging section (interim pre-center hall entry) Later expansion house (more formal stone shaping) 12 over 8 windows (late 18th century)

During the early colonial era defense specifications for frontier houses required them to be built of stone with full basements. The majority of surviving stone houses have expanded beyond this specification. Indicators of their original structure such as seams and mating lines and base-level entries are important for establishing age in historic houses and should remain visible and in good repair.

The original locations and sizes of window and door openings in stone walls should not be covered, resized or filled. Corbeled heads above window or door openings in stone walls are evidence of early construction and should not be restructured. If repairs to or bracing of window openings and lintels is necessary, it should be undertaken in a manner that leaves the stone as the primary visual element. Steel

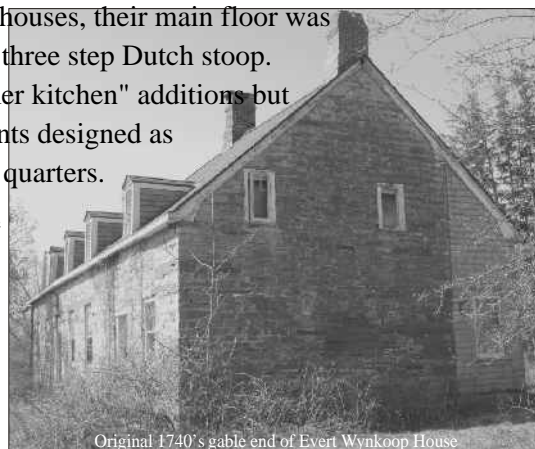
Original 1740's gable end of Evert Wynkoop House

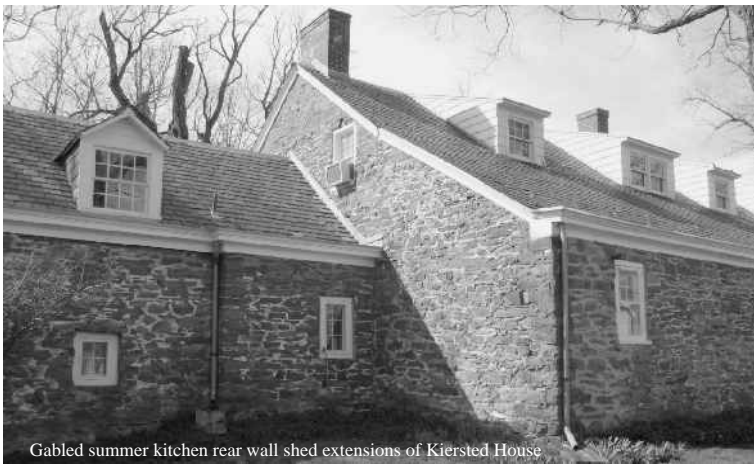
Gabled summer kitchen rear wall shed extensions of Kiersted House

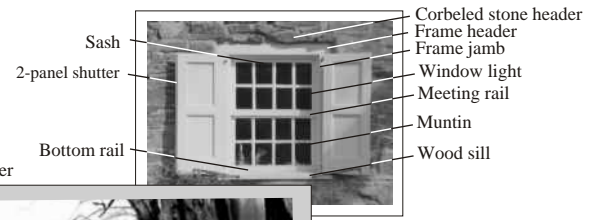
Parts of an 8-over-8 Kiersted House window

Typically Colonial and Federal era windows had a fixed upper sash and a moveable lower sash, known as a single hung sash. The windows consisted of multiple smaller panes of glass separated by wooden muntins. The earlier the window in general, the more the number of panes in a sash. Sash windows are described by the number of panes per sash. For example, 8 over 12 or 12 over 12 windows are characteristic of the Colonial and Federal Eras. By 1830 technology allowed larger panes of glass to be produced and one sees for the first time 6 over 6 windows and by 1850 2 over 2 windows. As styles evolved many homeowners of 18th and 19th century houses updated their windows with newer sash configurations with fewer panes. Colonial doorways had single or double (Dutch) doors without lights. 17th and 18th century doors consisted of

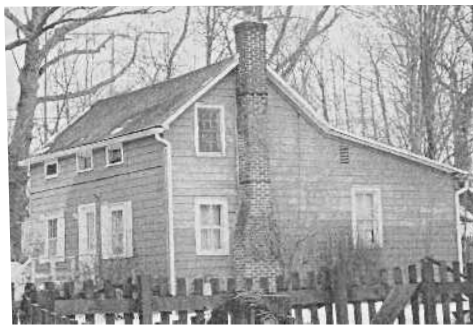
Dutch "H-bent" barn framing of late colonial Saugerties hamlet cottage

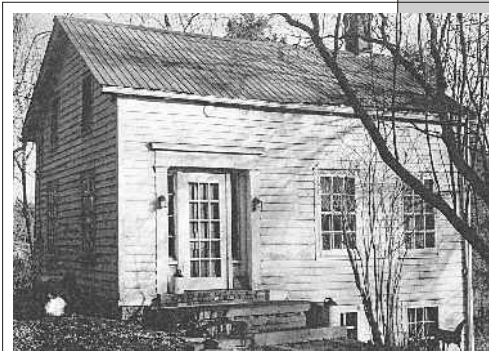
Classic framing on Malden Turnpike late colonial Saugerties hamlet cottage

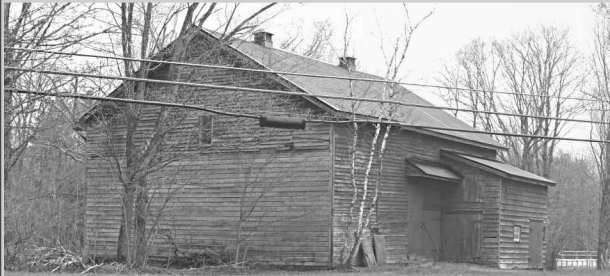
Early Colonial period timber framing insulation method using a clay and grass fiber paste progressively packed between clapboards outside and split sapling lathe inside. The lapped clapboards creates a form that leaves the pattern in the photograph.

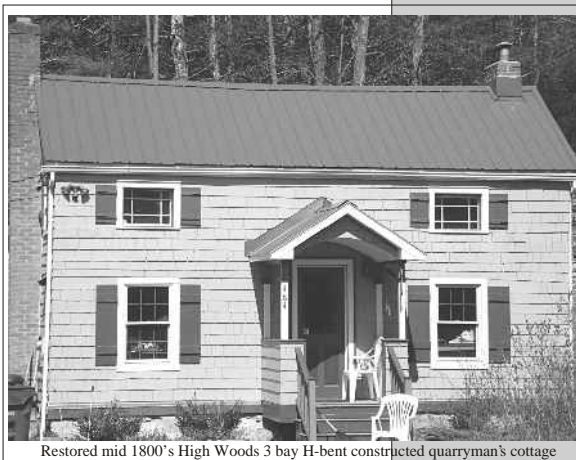
Restored mid 1800's High Woods 3 bay H-bent constructed quarryman's cottage

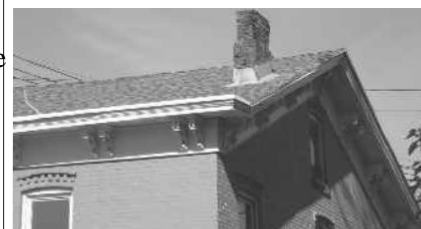
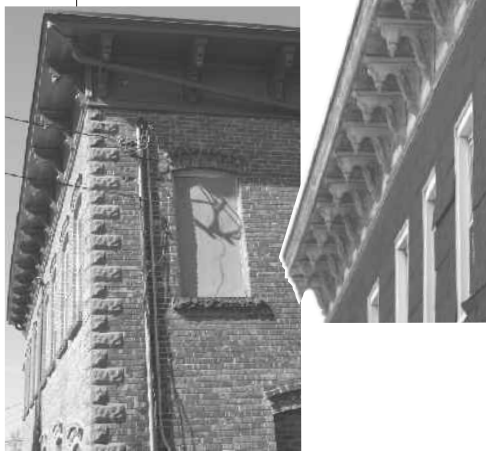
The bracketed cornice with broad frieze boards following the rake of the gable is a typical feature of the post Civil War Italianate style of Saugerties

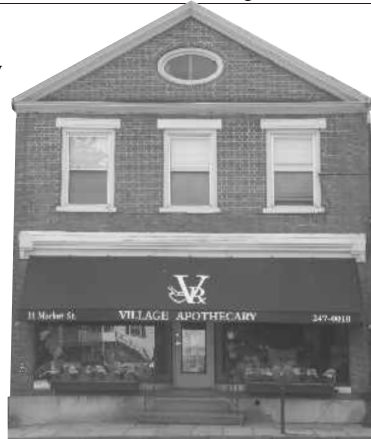
Rare Greek Revival store with Dutch cross course brick laid on bluestone water table band

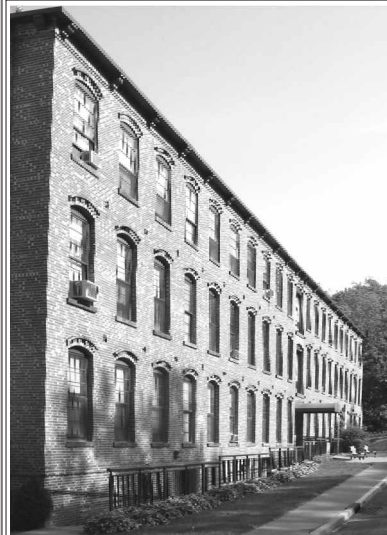
The west wall of "The Mill" with three floors of 21 arches each in their original 1887 condition

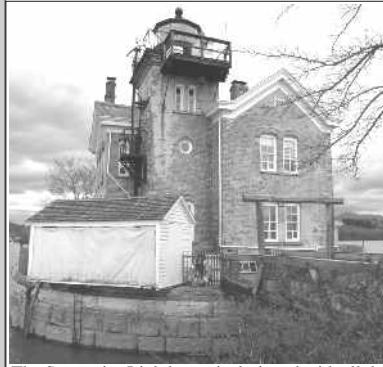
The Saugerties Lighthouse is designed with all the best features of the Saugerties Italianate style

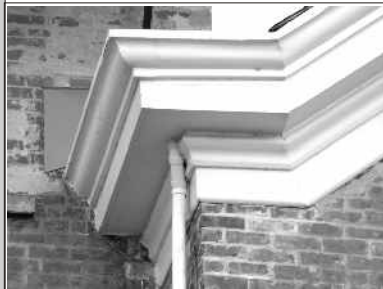
The box cornice that crowns the lighthouse's walls is a typical feature found throughout Saugerties

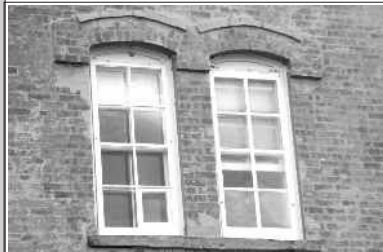
The hood-looking arch lintels above paired, common-silled windows are Italianate features
